# **Photo Log**

## Area 1 – Hazardous Waste Storage Area

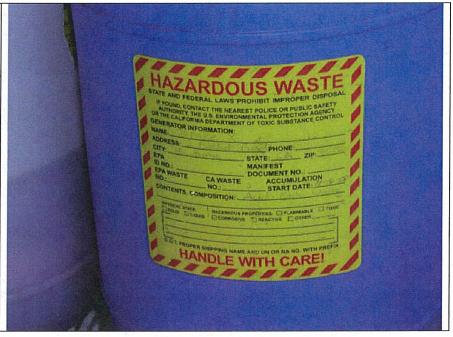
1-E

**Potential Violations:**

Storage of hazardous waste for longer

than 90 days.

Description: Label of acidic etch waste container (D002) with ASD of 11/16/08.

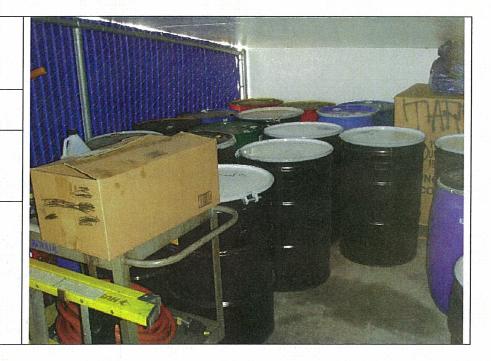
1-G

Potential Violations: Lack of aisle space

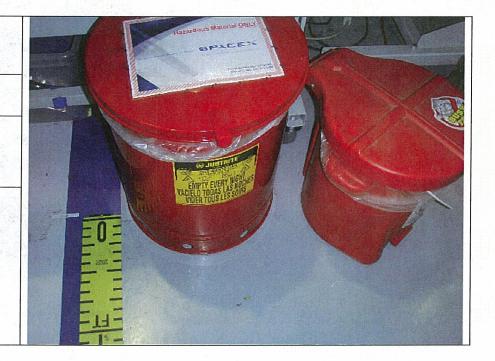
4-A

- Two 5-gallon flammable materials containers, one inside and one outside the Avionic's clean room, were labeled as "FOD Foreign Object Debris."
- Flammable materials containers (14-gallon Hazardous Material Only and 5-gallon FOD) throughout the facility have incomplete hazardous waste labels.

**Potential Violations:**

Improperly labeled containers of

hazardous waste
